OPEN-FILE REPORT O-98-02

**THE CAPES LANDSLIDE,
TILLAMOOK COUNTY, OREGON**

**MEMORANDUM TO MYRA THOMPSON LEE, DIRECTOR
OREGON EMERGENCY MANAGEMENT (OEM)**

February 1998

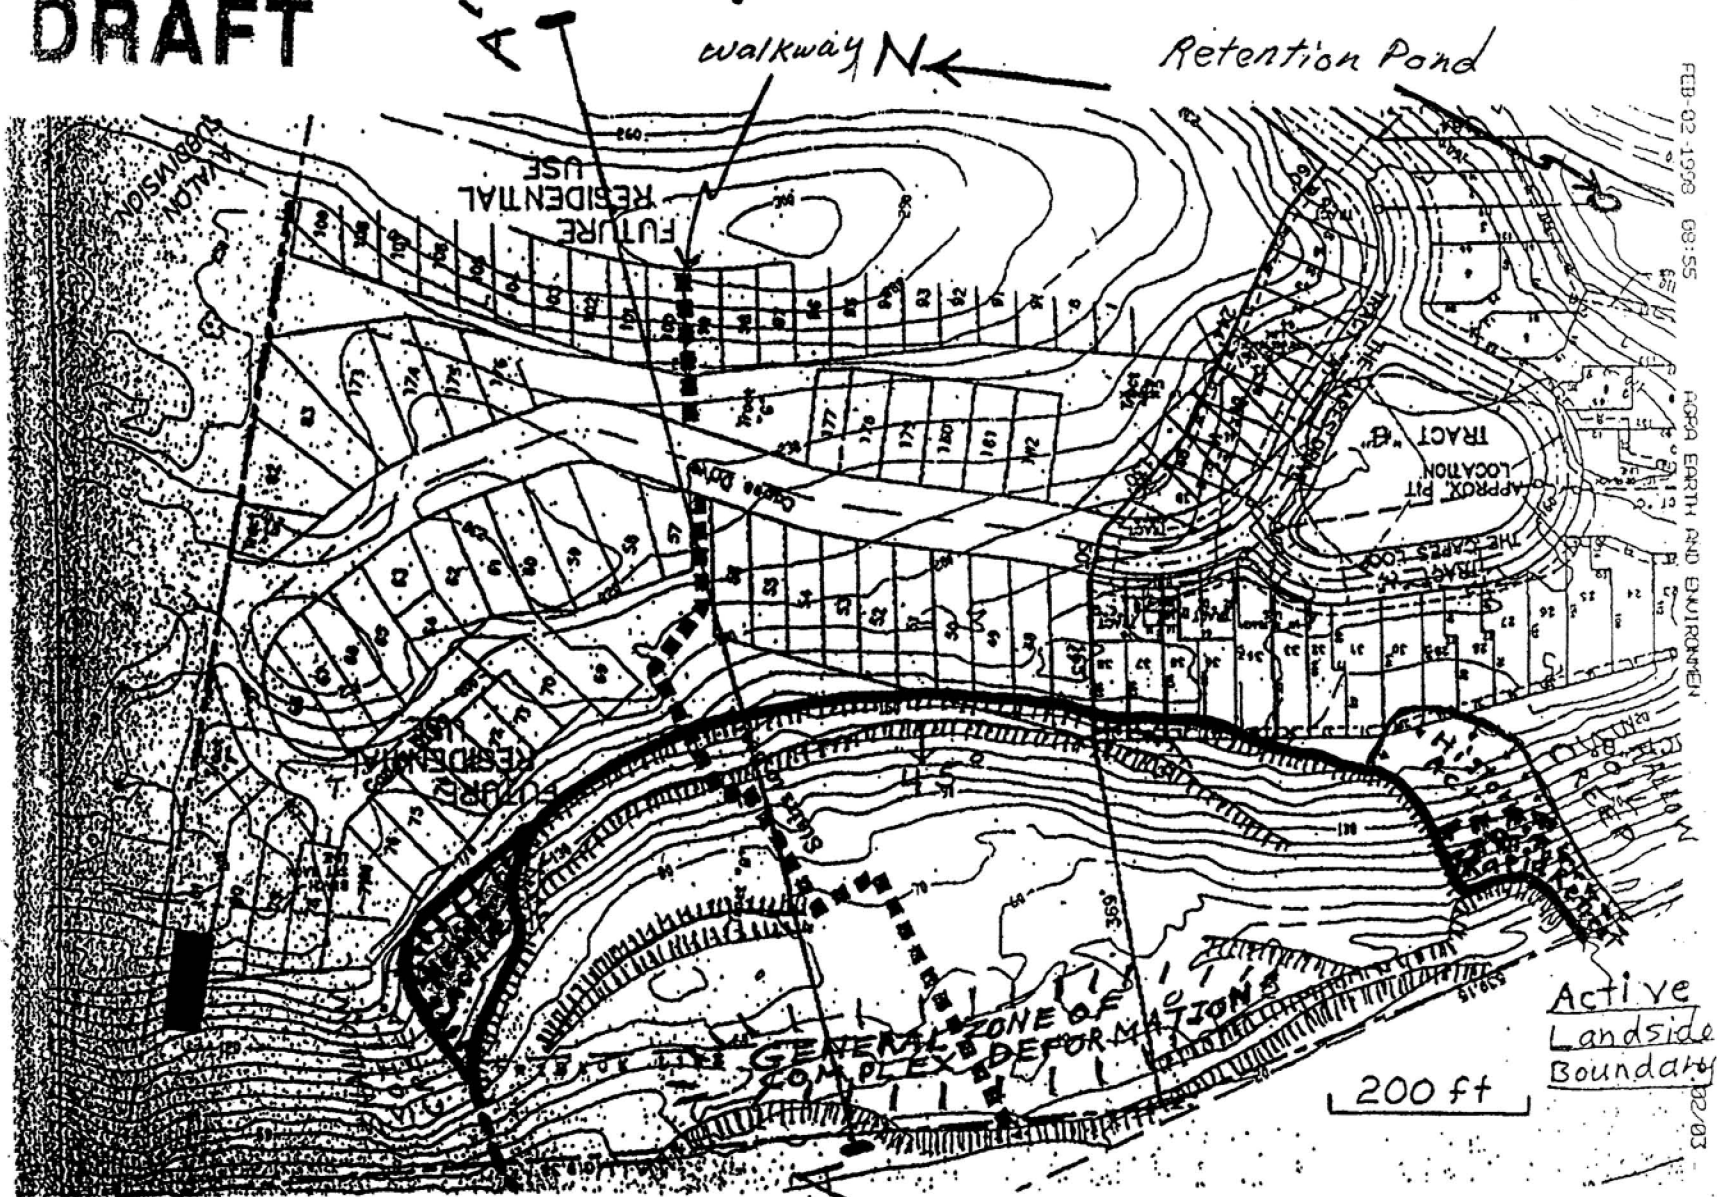
The Capes Landslide Map

The active ground movement is mainly confined to a 900-foot long (northwest-southeast) by 500-foot-wide (southwest-northeast) complex landslide that was in existence before the currently active movement (see attached map). The landslide cuts a thick (100 feet or more) mass of Holocene (<10,000 years old) Dune Sand overlying a thinner sequence of slightly consolidated Holocene mud interbedded with poorly sorted (many different sizes of particles) slightly to moderately consolidated debris flows, sands and silts with abundant logs and other dark-colored woody debris (see cross section). Some buried soils occur within this mud-debris flow unit, as evidenced by at least one upright tree stump. The mud is the apparent slip plane and overlies older (~15 million years) hard bedrock composed of Astoria Formation sandstones, minor mudstones, and interbedded submarine to subaerial Grand Ronde basalt.

A detention pond (see map) that reportedly accepts all storm water from the development is located on a possible margin for one of these potential ancient slide blocks. Water from this pond reportedly drains quickly into the underlying sand and could contribute to instability of both the potential ancient slide block and active landslide.

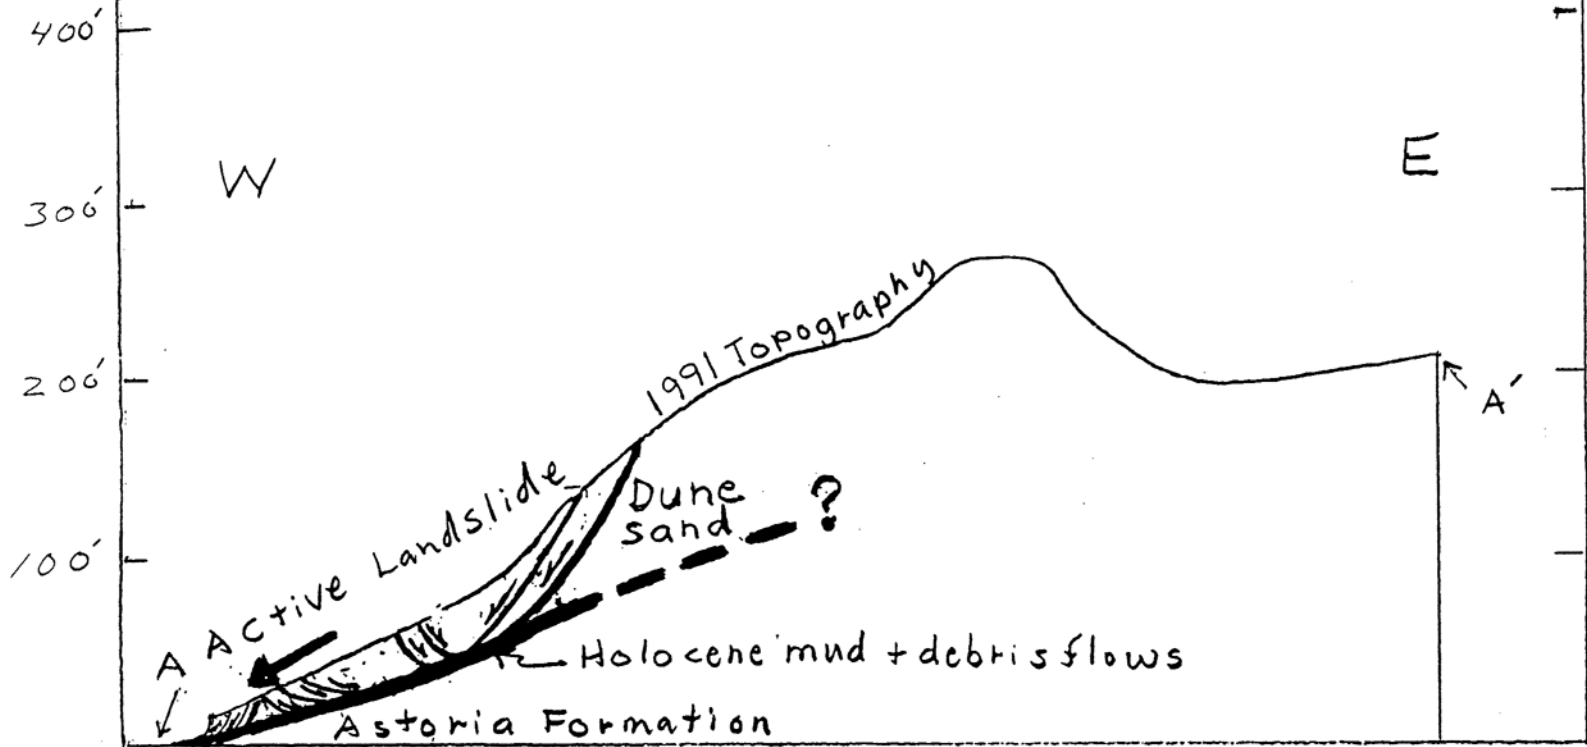
appeared minor (inches) but fairly constant. The stairway down to the beach has been damaged and sections have been removed. In recent weeks (and days) the slide movement has been accelerating and ground cracks have opened up at the crest of the slope approximately 8-10 feet behind lots 34-35 area on the southeast margin of the headwall (see attached map). Vertical drop in the lawns of these units was on the order of 18 inches on January 27, 1998. By Sunday, February 1, 1998, the drop had reportedly grown to about 5 feet. Fresh slumping has also occurred just slightly down slope from the same units. In the three days between my field visits the overall slope had moved significantly (from three to five or more feet) and fresh cracking had occurred further up slope on the northeast side of the headwall below lots 71-77. Rapid propagation of slope failure is also occurring below lots 28-30. At this point, the total vertical drop for the central part of the landslide would appear to be in excess of 14 feet. Rapid wave erosion at the toe of the landslide is causing sloughing of the toe and contributing to extensive lateral movement of the low mound of material at the toe (see map and cross section).
